①
UNDERWATER FACILITIES
INSPECTIONS
AND
ASSESSMENTS
AT

NAVAL EDUCATION
AND TRAINING CENTER
NEWPORT , R.I.

MAY 1981 FPO-1-81 (10)

CHILDS ENGINEERING CORPORATION
MEDFIELD, MASSACHUSETTS 02052

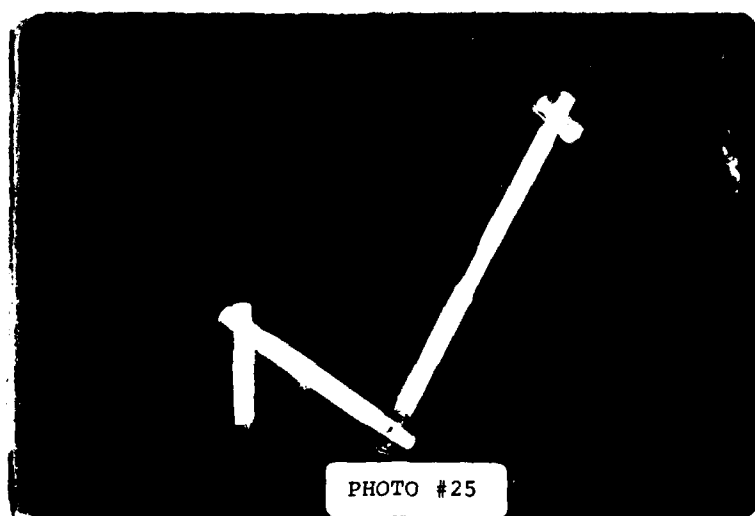
PHOTO #25

Photo # 25: Pile B in Bent 48 of the Quaywall Apron,
Showing a Hole in the Web and Corroded
Flanges Around Mean Low Water.
